**AL IQITADAR SCHOOL**  
**UNDER THE COMMANDER'S EMERGENCY RESPONSE PROGRAM**  
**ANBAR PROVINCE, IRAQ**

**SUSTAINMENT ASSESSMENT**

**SIGIR PA-08-141**  
**JANUARY 26, 2009**

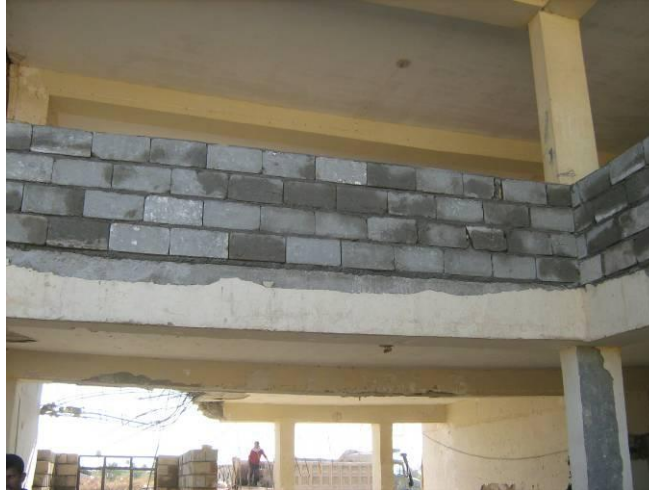
Site Photo 4 documents the building masonry work during rebuilding

Site Photo 4. Masonry work during rebuilding (Courtesy MNC-I)

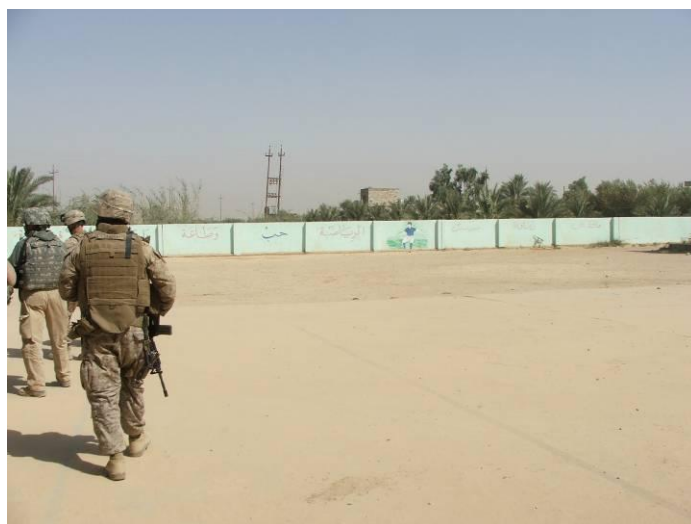
- removal of all debris on building premises
- repair of perimeter wall and gate (Site Photo 6)
- replacement of interior/exterior doors
- replacement of damaged windows

Site Photo 6. Perimeter wall

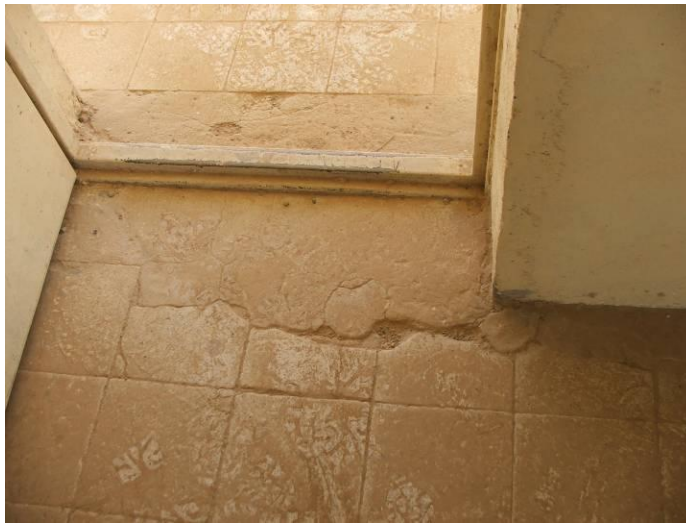
During the site visit, SIGIR observed the construction of the new classroom buildings. The roof tiles appeared to be in good condition throughout the expanse of the roof. There were drainage holes at the roof's edges, which will allow water to drain from the roof. The exterior and interior walls appeared to be adequately repaired/replaced. The majority of the interior tile and concrete floor work was good; however, there were areas of broken tiles and uneven floors (Site Photo 7).

**Site Photo 7. Uneven floors**

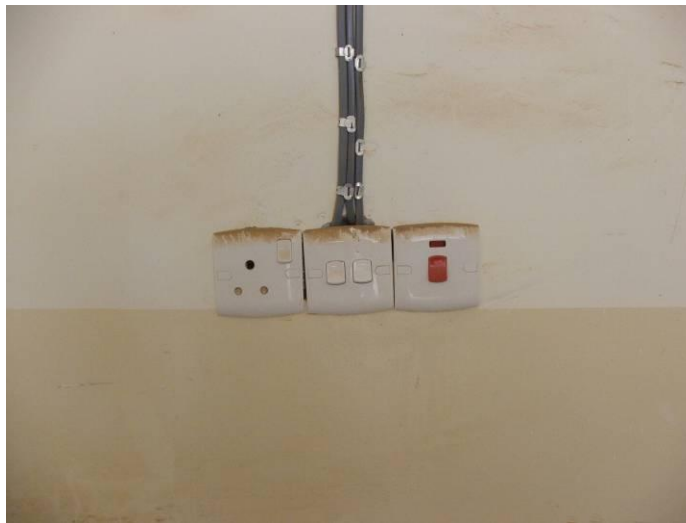
SIGIR verified the existence of the replaced wiring system by testing the newly installed switches, lighting fixtures, and ceiling fans (Site Photo 8). While going through the classrooms, SIGIR periodically tested the lights and ceiling fans, which were found to be functioning properly. According to the contract's SOW, the contractor was required to "install AC units." It did not appear that the A/C units or mounts for the A/C units were ever installed.

**Site Photo 8. Switches**

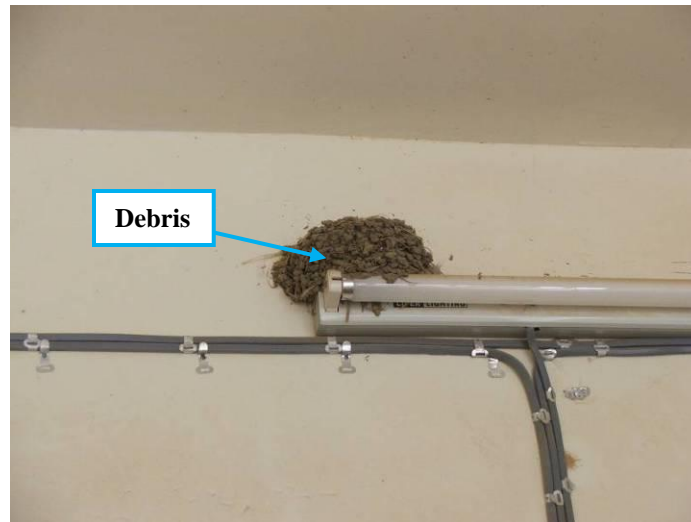
During the site visit, SIGIR did not detect any instances of potentially harmful electrical system tampering. However, some of the light fixtures housed debris from a lack of routine maintenance (Site Photo 9).

**Site Photo 9. Debris on light fixture**
